SLOT TECH MAGAZINE

Slot Machine Technology for the North American Gaming Industry

EZ PAY Made EZ
JAMES BORG'S
HOLE IN ONE

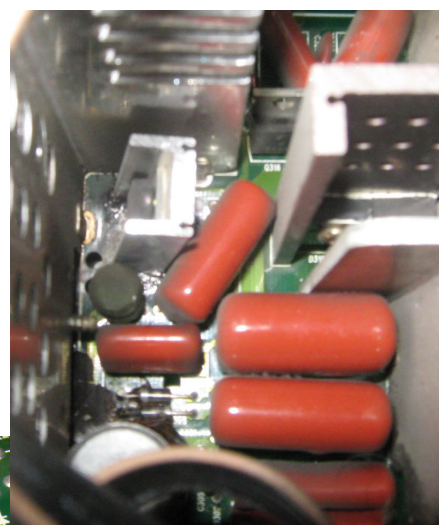
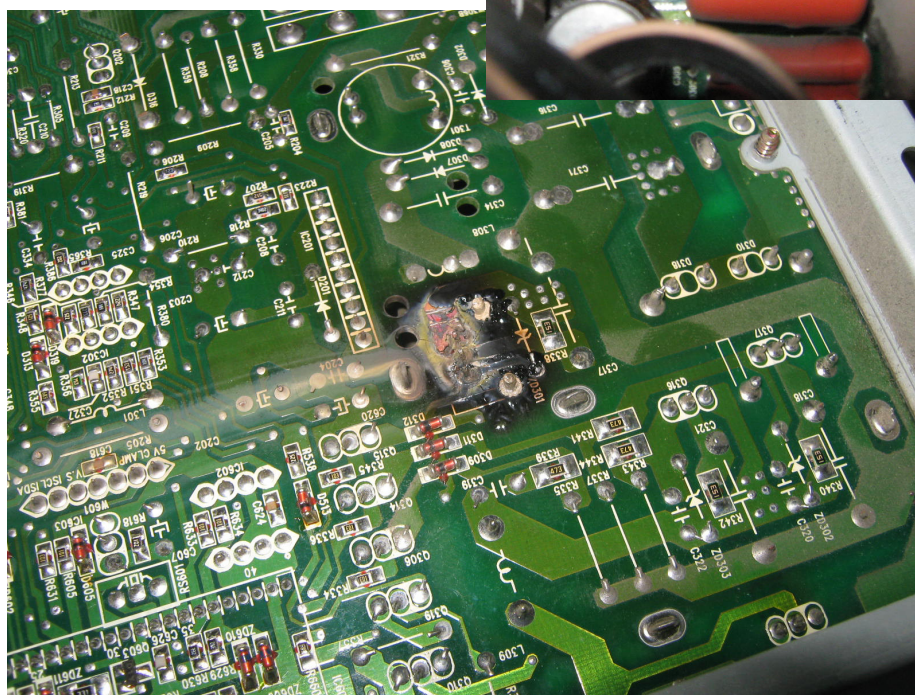
Fig. 2 Top View of Q318 (about to drop off)

Q316, Q317, Q318 are off when horizontal frequency is 62KHz ~ 70KHz.

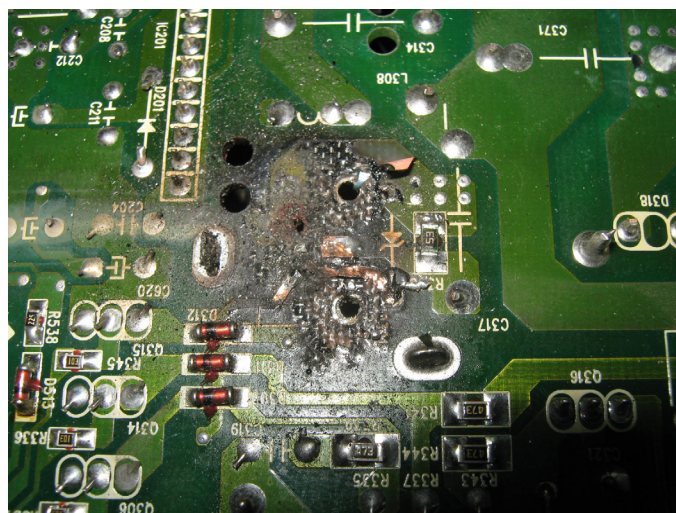
Disappearing Tracks

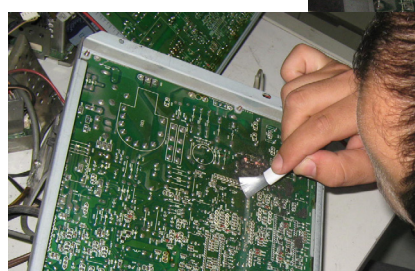
Removing the Carbon

Having found the damaged area on the schematic, it was high time to pull out the offending articles from the printed circuit board. That was going to be easier said than done, reason being that the board, along with the component legs and the solder, had all been cooked nicely and the solder would not flow enough to be sucked off the tracks. I'll rephrase that, what's remained of the tracks.

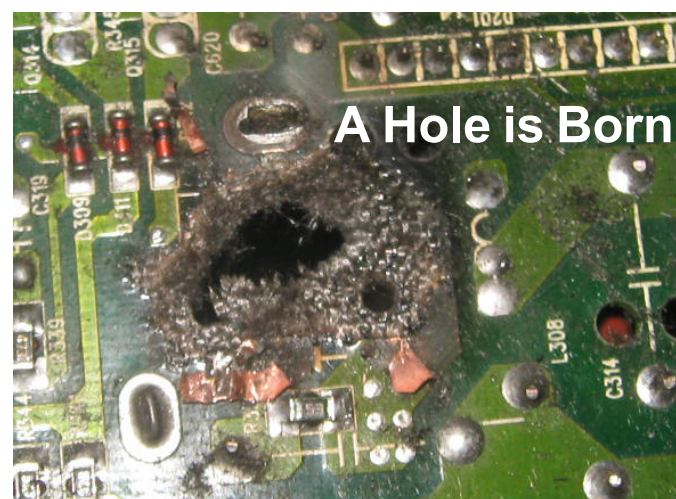
A Hole is Born

With that nice gaping hole present where before tracks used to be, was going to prove somewhat difficult to insert the new IRF640. The only way to do it was to fit the component somewhere safe, and have wires leading to where it should have been on the print.

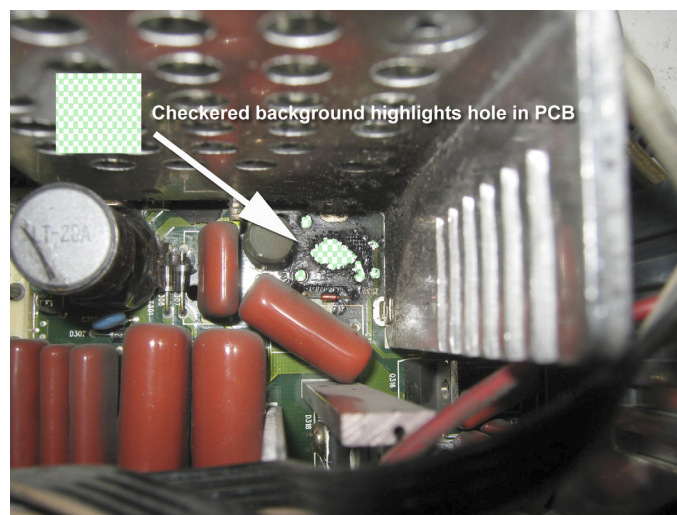
Top View of Hole

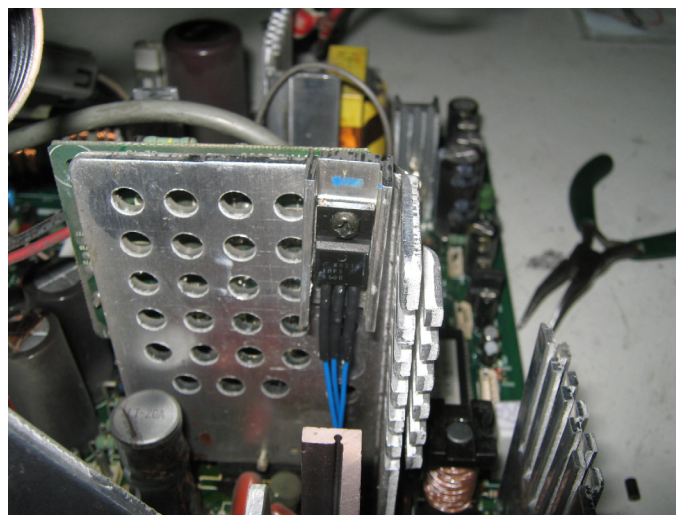
IRF 640 Mounted

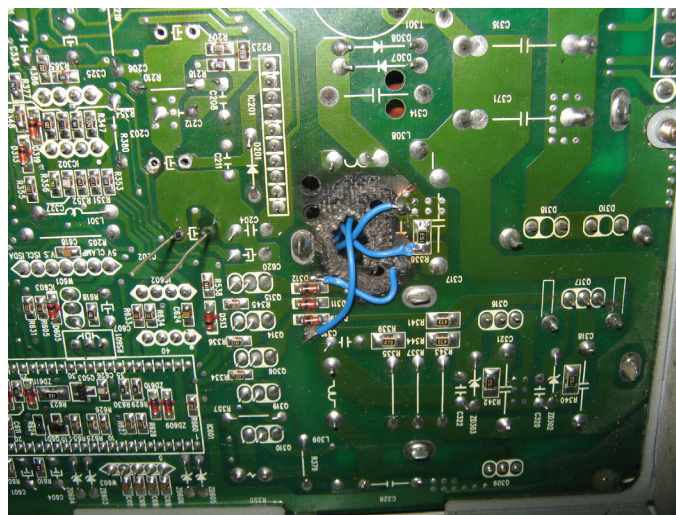
Using Flying Leads as Track Replacements

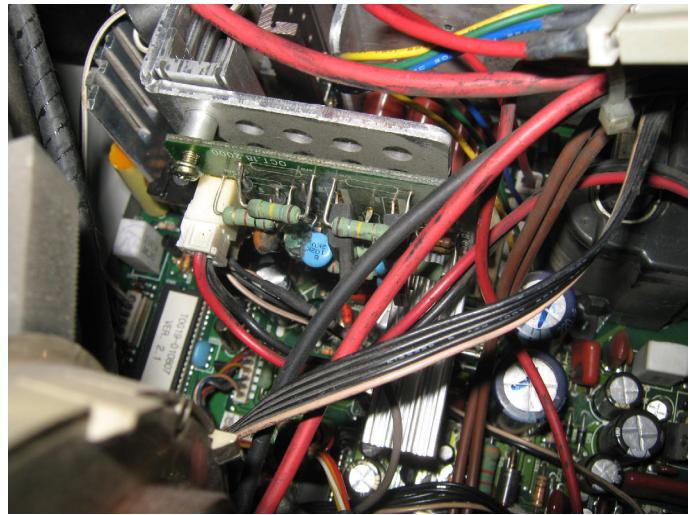
DF (Dynamic Focus) Board

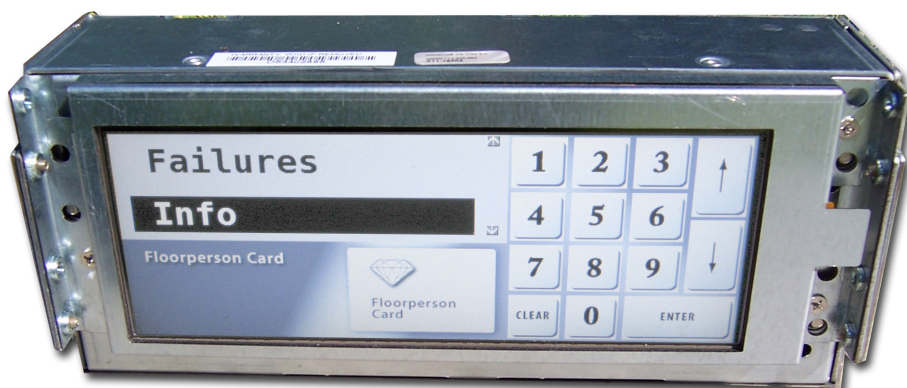
FIGURE B shows what the display looks like when a floor card is inserted. Notice the touchscreen keypad?

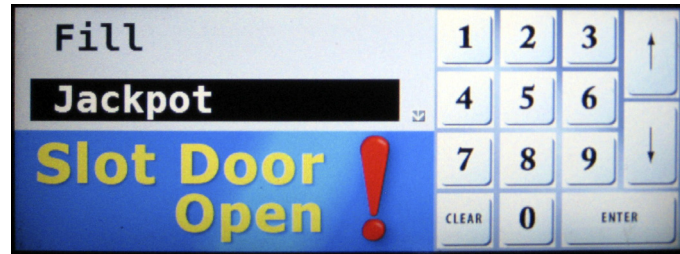
FIGURE E is a picture of what the display looks like when a floor card is inserted and the slot door is open.
