**M**anufacturers'  
**B**ill  
**A**ceptor

**INSTALLATION  
SERVICE & PARTS MANUAL**

**Ardac**®  
Incorporated

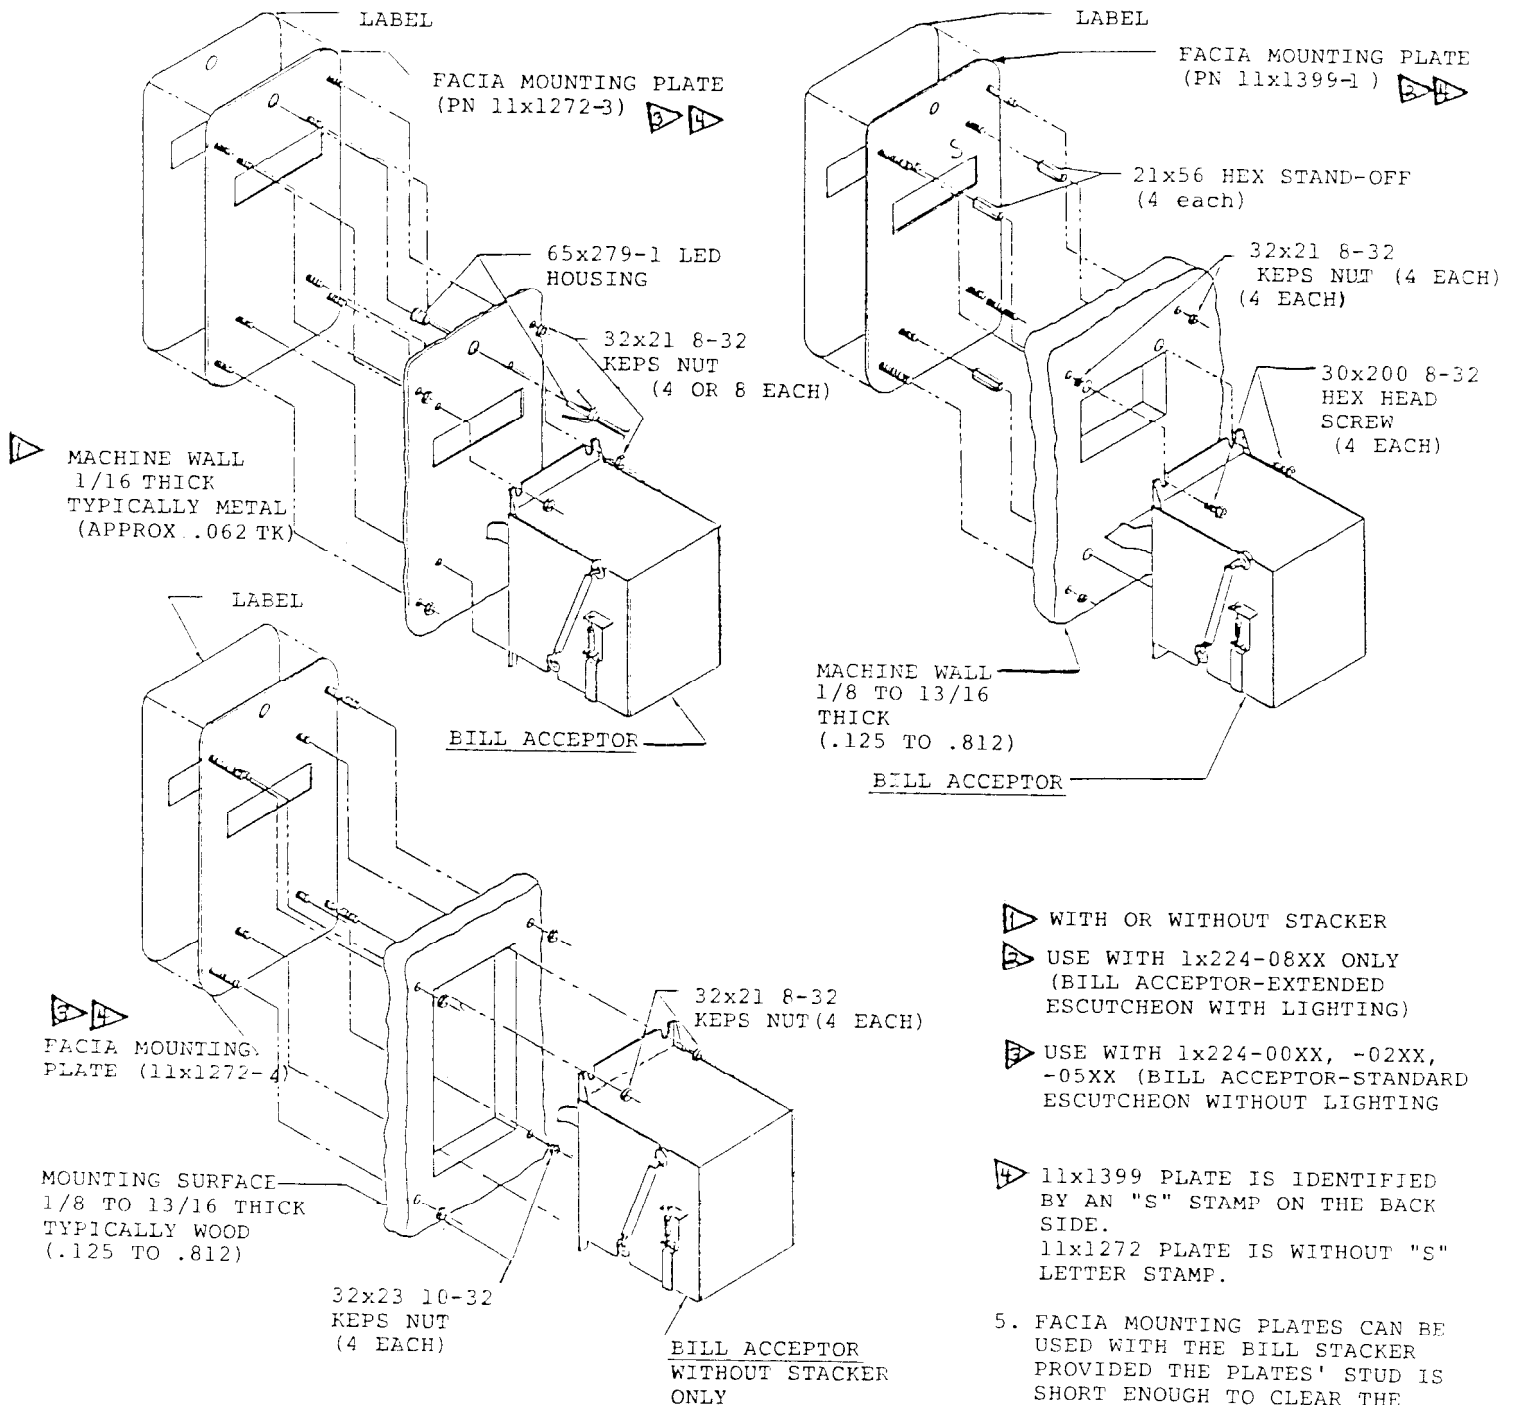
MBA RETRO-FIT MOUNTING PLATES  
TYPICAL INSTALLATIONS

- ▶ WITH OR WITHOUT STACKER
- ▶ USE WITH 1x224-08XX ONLY (BILL ACCEPTOR-EXTENDED ESCUTCHEON WITH LIGHTING)
- ▶ USE WITH 1x224-00XX, -02XX, -05XX (BILL ACCEPTOR-STANDARD ESCUTCHEON WITHOUT LIGHTING)

▶ 11x1399 PLATE IS IDENTIFIED BY AN "S" STAMP ON THE BACK SIDE. 11x1272 PLATE IS WITHOUT "S" LETTER STAMP.

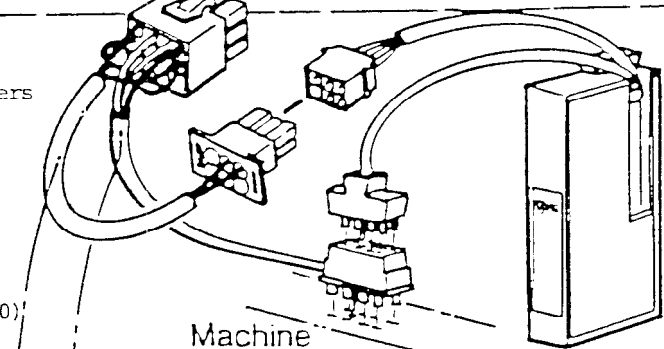
## HI LEVEL INTERFACE

- 1.....MBA T-Adapter shown connected to "HI-LEVEL" changers  
COINCO...models S300E9240  
F300E9210  
(extra adapter CA #406277)  
9340-S  
MARS....models MC5802  
MC6200  
MC5807  
MC5920ADH (4 price)  
(extra adapter ARDAC PN 99x0019-10)  
MAKA.....model US111

The ARDAC MBA interfaces to all dollar capable coin changers by one of 2 methods.

1. HIGH LEVEL: One end of machine harness to Control Box (21-Pin connector), other end must go through ARDAC T-Adapter to the coin changer.  
1) High Level uses 110 VAC.  
12-pin Mate-N-Lock to ARDAC T-Adapters 12-pin Mate-N-Lock.  
6-pin Jones plug to machine along with 8-pin Jones from Coin Mech.  
6-pin Molex from T-Adapter to 6-pin Molex from Coin Mech.
2. LOW LEVEL: One end of machine harness to Control Box (21-pin connector), other end directly to the coin changer (12-pin Mate-N-Lock).  
3) Low Level uses 5 VDC.

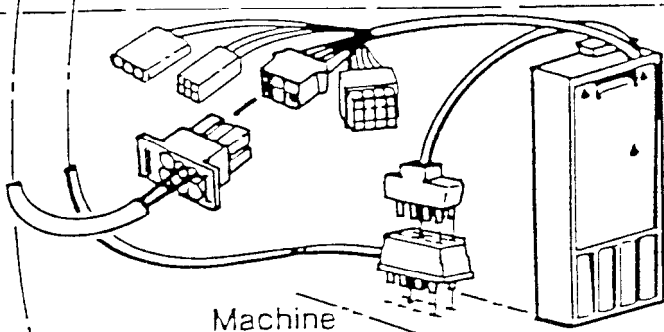
## OPTIONAL HI/LOW LEVEL INTERFACE

- 2.....MARS.....model TRC6800H

HI-LEVEL Interface shown, LO-LEVEL Interface  
same as 3.

NOTE: Some coin changers such as Mars model TRC6800H as shown, will work either way. See Figure 2.

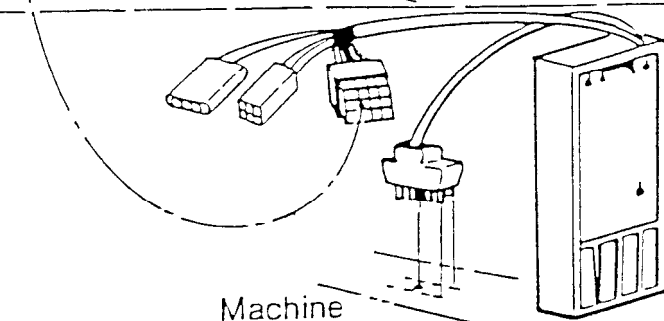
## LOW LEVEL INTERFACE

- 3.....MARS.....models MC5800DH  
MC5805DH  
TRC6800H

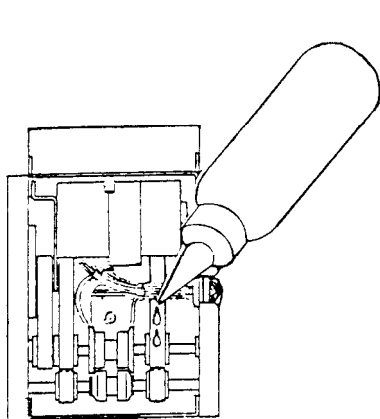
FIGURE 1

- 1a. With the motor still running, use a soft paper towel to dry and clean the belts (see Figure 1), one at a time. Apply as many times as necessary until no more dirt or oil can be removed.

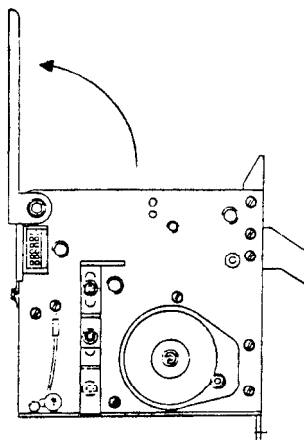
FIGURE 2

2. The black timing belt may be cleaned in the same manner as above.
3. Open the acceptor cover as shown in Figure 2. With the acceptor motor still running, as above, apply isopropyl alcohol to the idler belts (outer side). See Figure 3, #1.

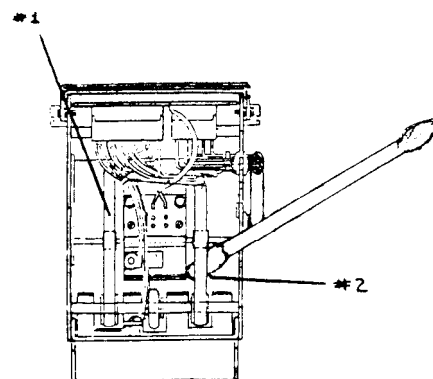
FIGURE 3

4. It is necessary to also clean the inner side of the idler belts. If the inside of the idler belts are oily, the idler belts may be driven off their rollers. In this procedure, it is necessary to place a Q-tip soaked with isopropyl alcohol underneath the idler belt (see Figure 3, #2).

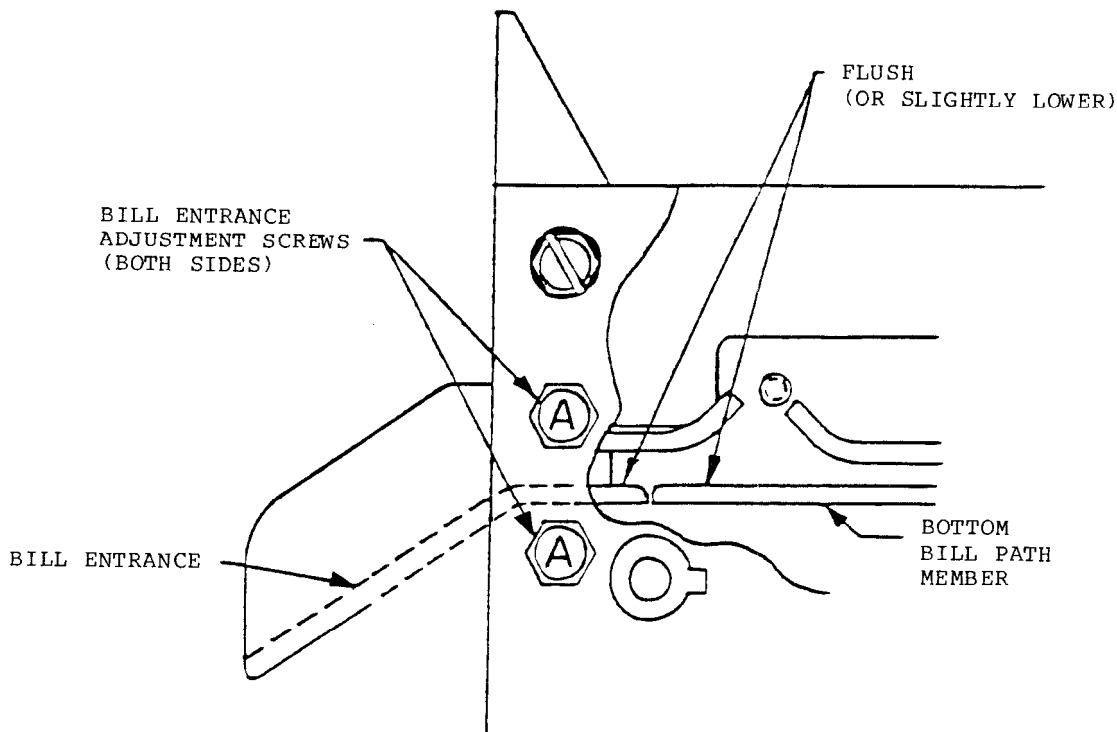
FIGURE 1

### ADJUSTMENT 1 - BILL ENTRANCE

The bill entrance escutcheon should be adjusted vertically so that its bill path surface is flush with the bill path surface of the bottom bill path member. To adjust, loosen the four screws(A), (2 of each side), position the escutcheon, then tighten the top screw on the right-hand side and then the bottom screw on the left-hand side, then tighten the remaining two screws. Refer to Figure 1.

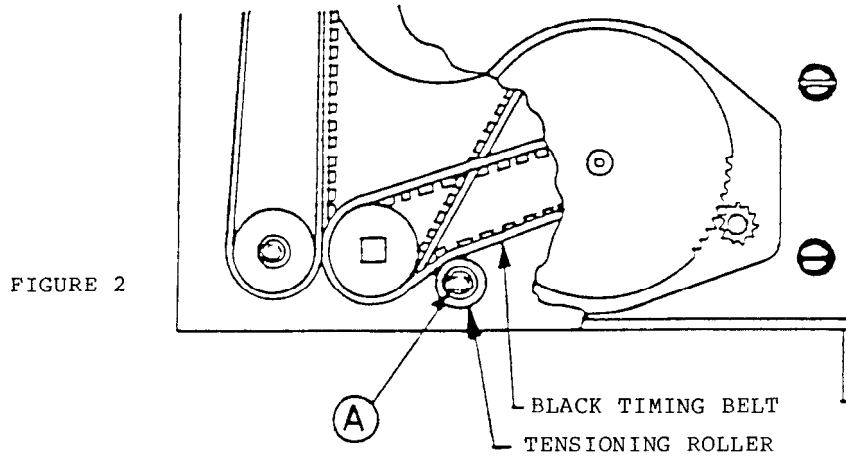
#### ADJUSTMENT 2 - BLACK BELT TENSION

Check the tension of the black timing belt. If an adjustment is required, loosen screw (A) in Figure 2; reposition the roller and tighten screw (A). The belt should be just tight enough to avoid skipping teeth.

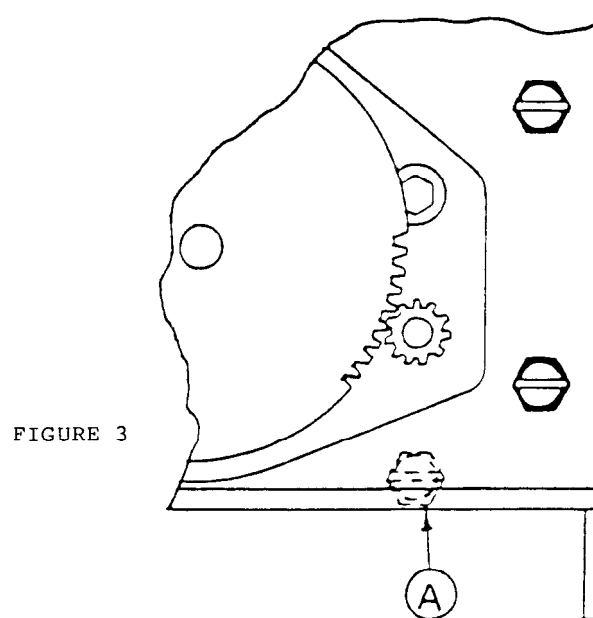
#### ADJUSTMENT 3 - GEAR MESH

Visually check the gear mesh so that the teeth of both gears overlap approximately 2/3, and so that there is some rotational play in their mesh. These adjustments should be checked in 4 places, 90 degrees apart, which you can mark on the large plastic gear. The adjustment is made by loosening with an open end wrench to a snug position the motor screw (A) in Figure 3, and rotating the motor so that the motor gear moves towards or away from the large plastic gear as required. Tighten screw (A) fully and recheck.

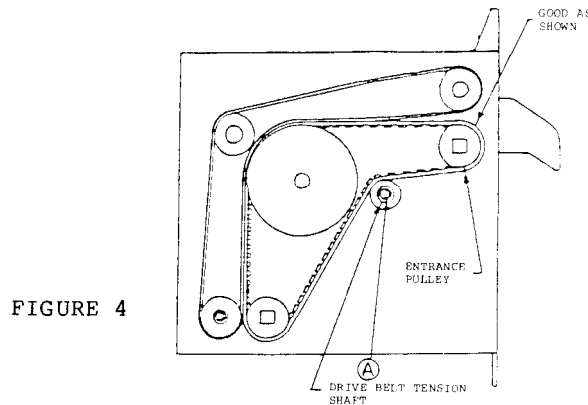
#### ADJUSTMENT 4 - DRIVE BELT TENSION

Adjust the tension of the gray timing belts so that no raising of the belts occurs just past the entrance pulleys. Rotate the belts by manually rotating the large drive gear on the left side of the acceptor with the power removed from the acceptor. Adjust the tension by loosening the drive belt tension shaft mounting screws (A) (one screw on each side) and pushing the shaft into the belts to increase the tension away from the belts to reduce the tension; then tighten screws (A). Refer to Figure 4.

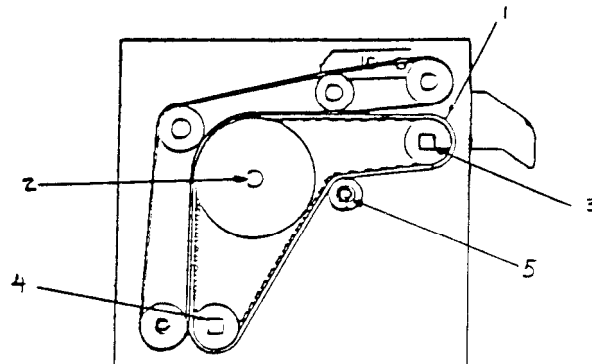
##### MBA BILL ACCEPTOR TIMING BELT REMOVAL AND REPLACEMENT - GRAY BELTS

7. Put the screws and E-rings back in. The holes with slots require screws with a lockwasher and a flatwasher.
8. Now the right-hand side plate can be removed and the same procedure as outlined above should be followed for replacing the right-hand timing belt. The wiring harness need not be removed, just carefully move it to the side while removing the side plate.

9. Once all the parts are assembled, adjust the acceptor following the adjustment section of this manual.

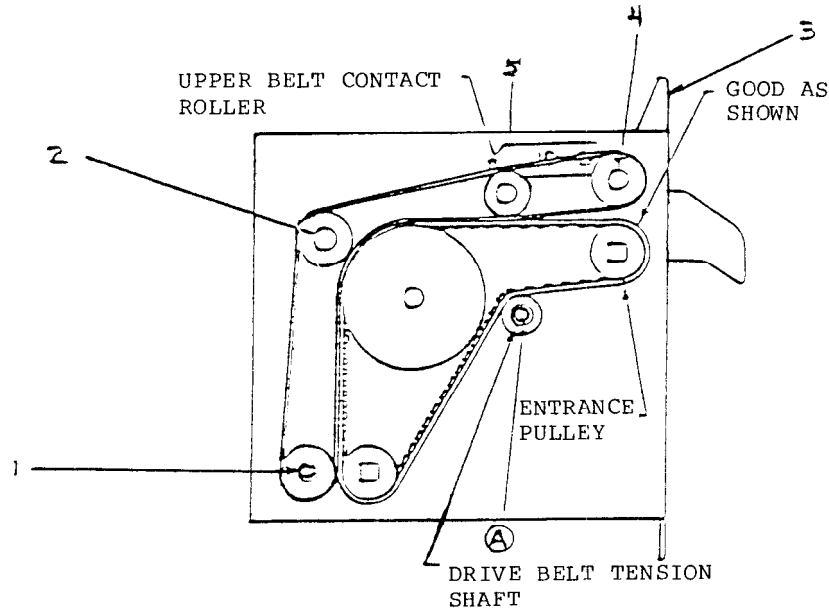
#### MBA BILL ACCEPTOR IDLER BELT REMOVAL AND REPLACEMENT - CLEAR/BLACK BELTS

1. Remove the acceptor cover.
2. Remove the back plate assembly.
3. Remove the rear idler shaft (Item 1) and the corner idler shaft (Item 2).
4. Remove the top front spacer (Item 3) and the front idler shaft (Item 4). On 1x224-050X and 1x224-060X series acceptors, the magnetic head mount shaft must be removed via the E-ring assembly.
5. Now the idler belts (Item 5) can be removed by pulling the belts out near the front of the acceptor. NOTE: IDLER BELTS SHOULD BE REPLACED IN PAIRS! See the figure below.
6. Replace the idler belts and reassemble the acceptor in reverse order.
7. Once all the parts are assembled, adjust the acceptor following the adjustment section of the manual.

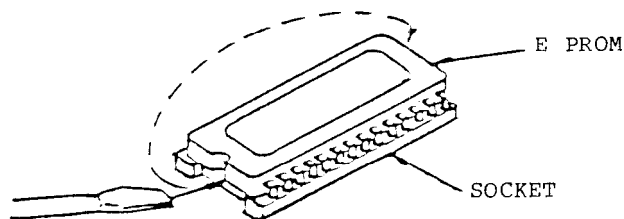
### INSTRUCTIONS FOR EXCHANGING E PROMS IN MBA CONTROL BOXES

1. Turn off the power to the control box and disconnect the 120 VAC power cable (3-pin plug).
2. Remove the cover from the control box by removing the (4) screws and disconnecting the stacker plug.
3. Carefully remove the E PROM using a small flat blade screwdriver. Insert the blade BETWEEN the E PROM and it's socket and GENTLY PRY UP on both ends evenly.

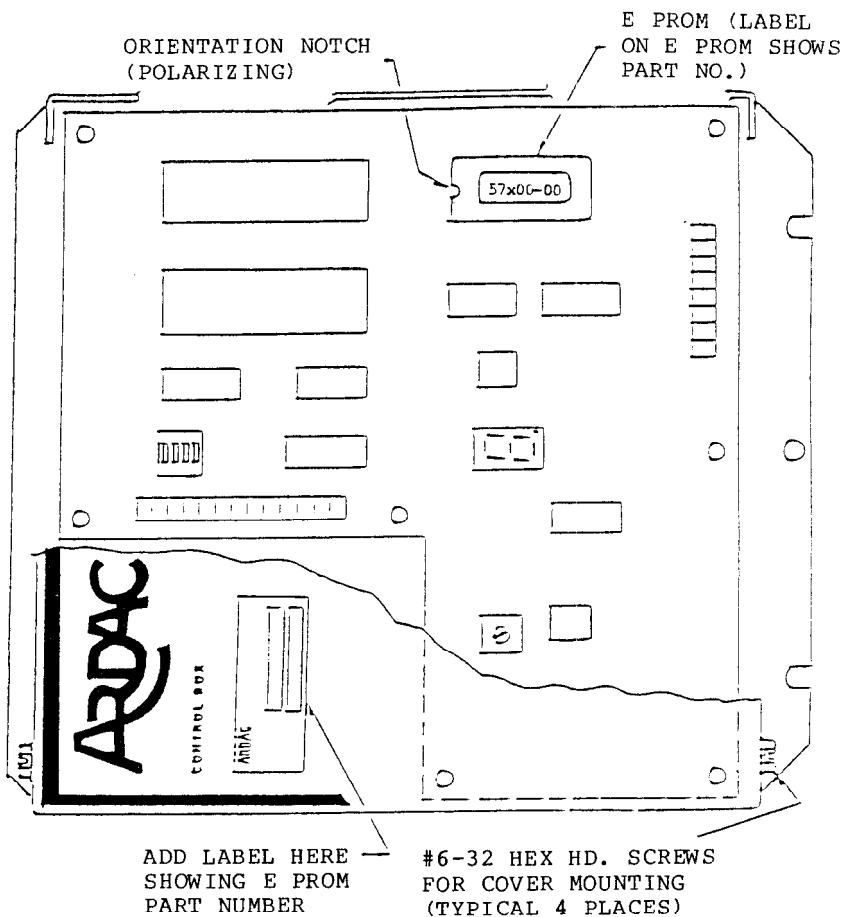
4. Carefully align and match the pins to insert the new E PROM in the socket with the orientation notch toward the center of the board. See the control box diagram.
5. Double check to see that all 28 pins are in the socket correctly.
6. Put the cover back on and plug in the stacker cable.

CAUTION!! Refer to the control box diagram for the location of the E PROM and proper polarization.

If plugged in wrong, the E PROM will be ruined.

It is suggested that the label included with the E PROM be applied to the outside cover as shown at the bottom of this page to identify converted boxes.

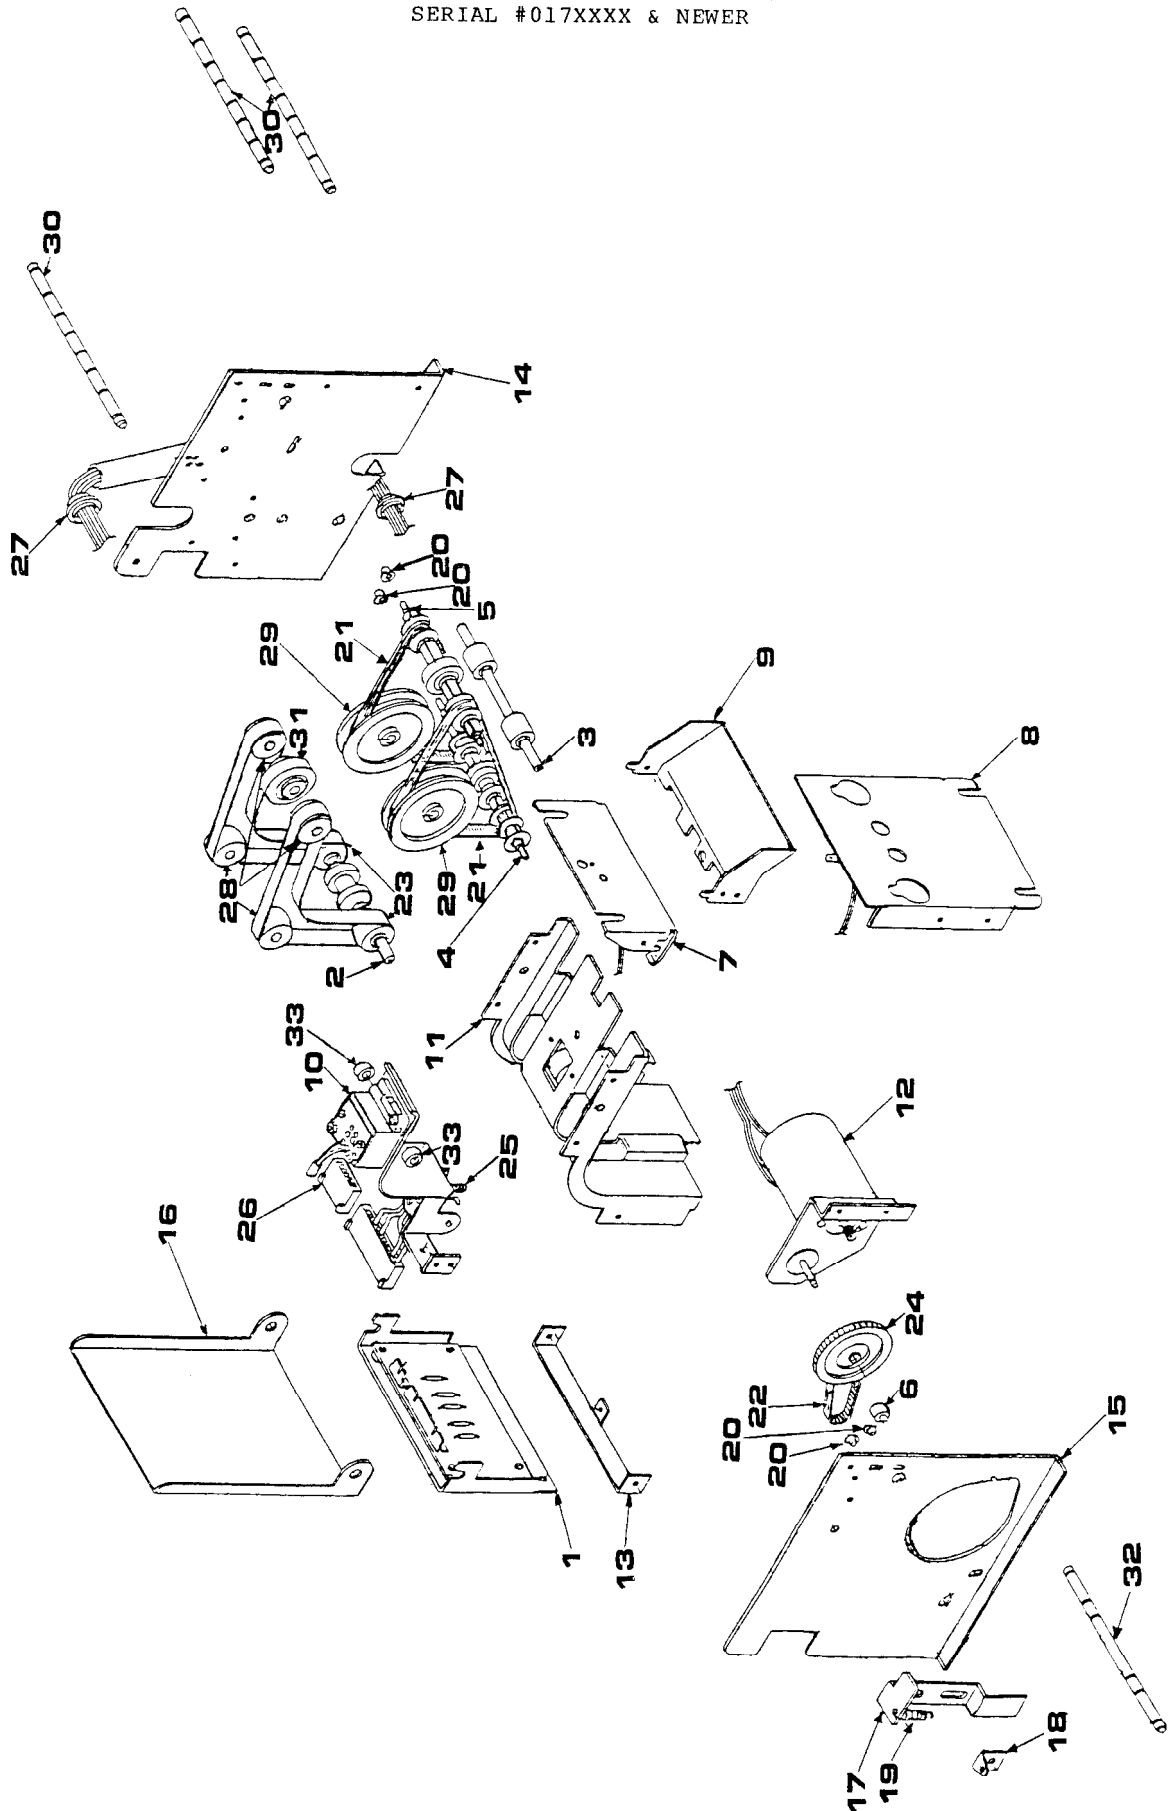
1X224-0501 MBA NOTE ACCEPTOR  
SERIAL #017XXXX & NEWER

1X224-0501 MBA BILL ACCEPTOR

ITEM	PART NUMBER	DESCRIPTION	ITEM	PART NUMBER	DESCRIPTION
1	2x3936-1 2x3968-4 12x460-1	Back Plate Assy P.C. Board Plate	12	11x1166	Rear Spacer
2	2x4360 20x576 17x846 17x800	Rear Idler Shaft Assy Shaft Note Forming Wheel Idler Roller	13	11x1156-2	Plate, Right-Hand
3	2x3944 20x512 17x803	Take-Up Shaft Assy Shaft Take-Up Pulley	14	11x1157-2	Plate, Left-Hand
4	2x4145 20x516 17x848 18x67 18x69	Main Drive Shaft Assy Shaft Note Forming Roller Pulley - Gray Belt Pulley - Black Belt	15	12x455-1	Cover Plate
5	2x3947 20x523 18x67 2x3947-1	Front Drive Shaft Shaft Pulley Note Centering Wheel	16	12x456	Latch Stacker
6	2x3948 20x526 17x811	Drive Belt Take-Up Roller Shaft Roller	17	12x457	Latch Spring Mount
7	2x3950 11x1243 2x4091	Upper Spacer Assy Upper Spacer Detector Assy	18	33x13	Spring Latch
8	11x1161-1	Escutcheon	19	19x9	Bearing, Drive Shaft
9	2x4210	Top Bill Guide	20	29x82	Gray Drive Belt
10	2x4143	Bottom Bill Track	21	29x83	Black Drive Belt

11	2x3964	Motor Assy	22	29x84	Idler Flat Belt
			23	18x71	Pulley & Gear
			24	33x143	Spring
			25	35x357-6	Plug, 6-pin
			26	17x8	Grommet
			27	17x800	Roller
			28	17x802	Pulley Drum
			29	20x555	Shaft
			30	17x813	Note Centering Wheel
			31	20x554	Shaft
			32	17x869	Roller

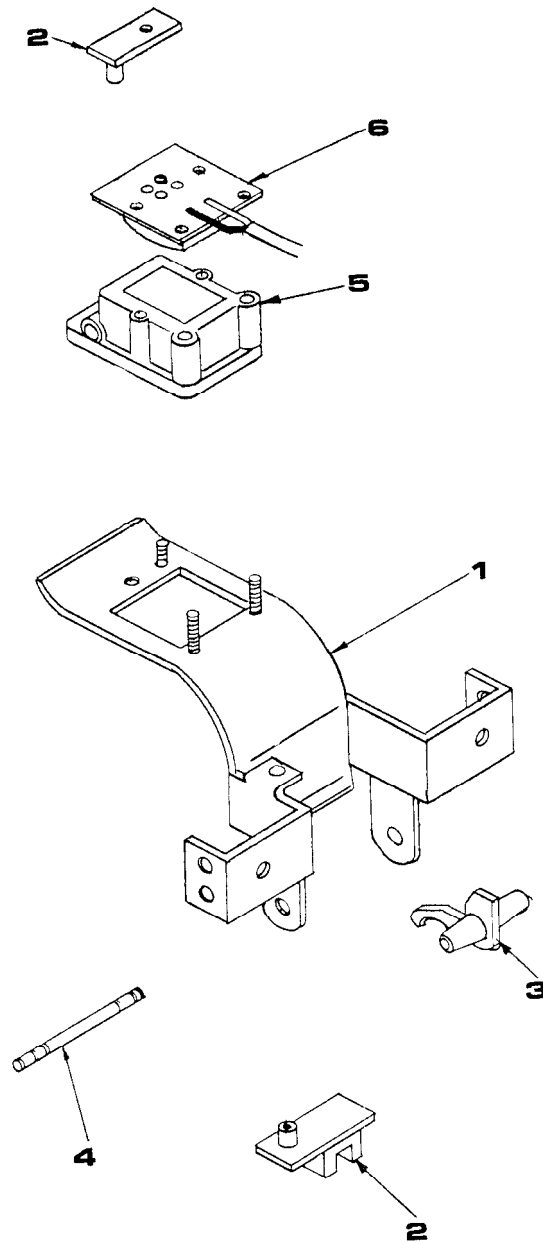
2X4210 TOP BILL GUIDE  
SERIAL #046XXXX & NEWER

ITEM	PART NUMBER	DESCRIPTION
1	11x1159-1	Top Bill Guide
2	2x4150 56x148	Harness Rear Clear Assembly Rear Clear Opto-Interrupt
3	17x833	Optical Interrupt Vane
4	20x518	Shaft Rear Clear
5	17x868	Mount - Mag Head
6	2x4211	Mag Head

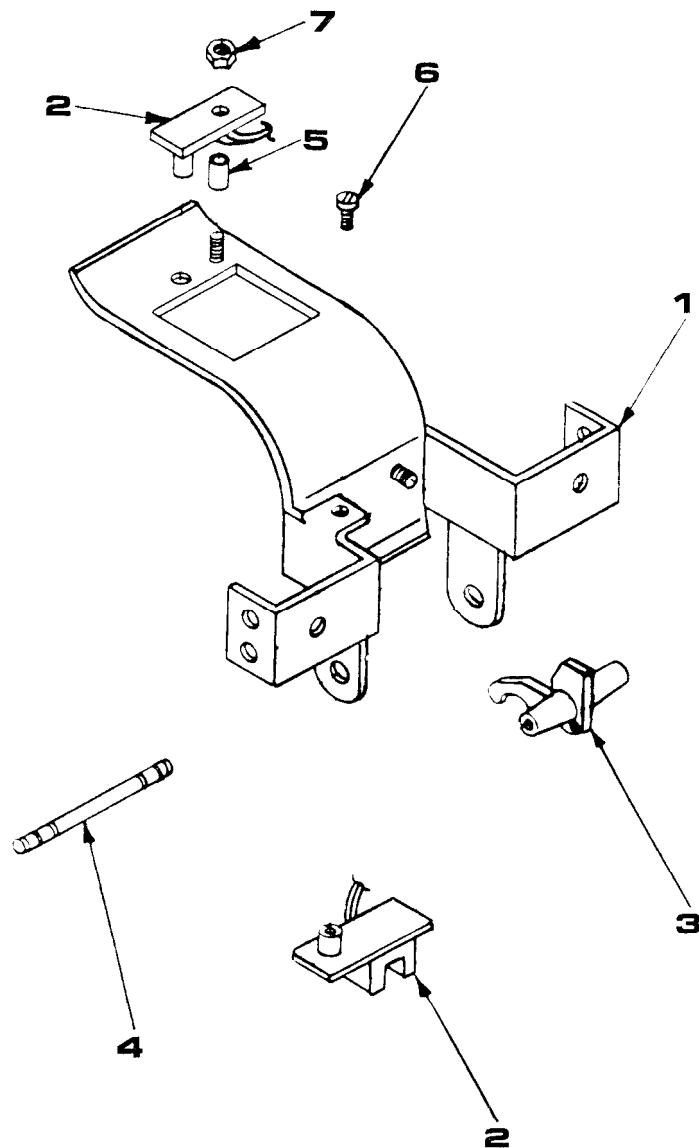
2X4092 TOP BILL GUIDE  
SERIAL #036XXXX & EARLIER

ITEM	PART NUMBER	DESCRIPTION
1	11X1159	Top Bill Guide
2	2x4150 56x148	Harness Rear Clear Assembly Rear Clear Opto-Interrupt
3	17x833	Optical Interrupt Vane
4	20x518	Shaft Rear Clear
5	21x35	Spacer
6	30x44	#2-56 Screw
7	32x22	#4-40 Keps Nut

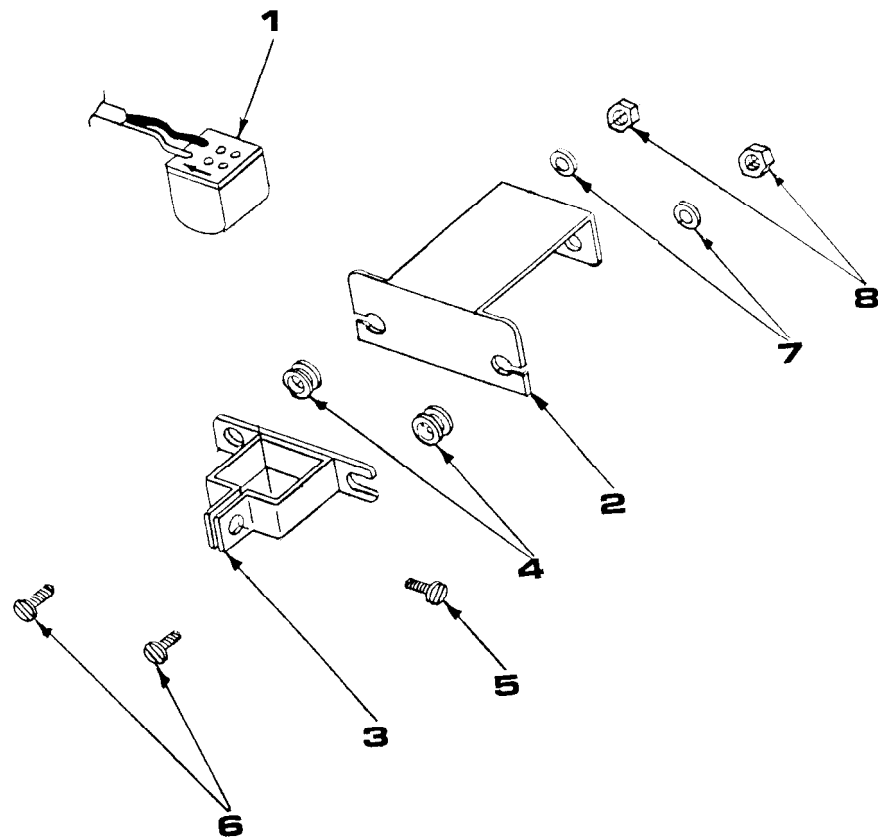
2X3962 MAGNETIC HEAD & MOUNTING  
SERIAL #036XXXX & EARLIER

ITEM	PART NUMBER	DESCRIPTION
1	2X3961	Magnetic Head Assembly
2	11x1167	Mounting Magnetic Head
3	11x1168	Magnetic Head Retainer
4	16x43	Grommet
5	30x44	#2-56 Screw
6	30x73	#2-56 Screw
7	31x14	#2 Flatwasher
8	32x12	#2-56 Hex Nut

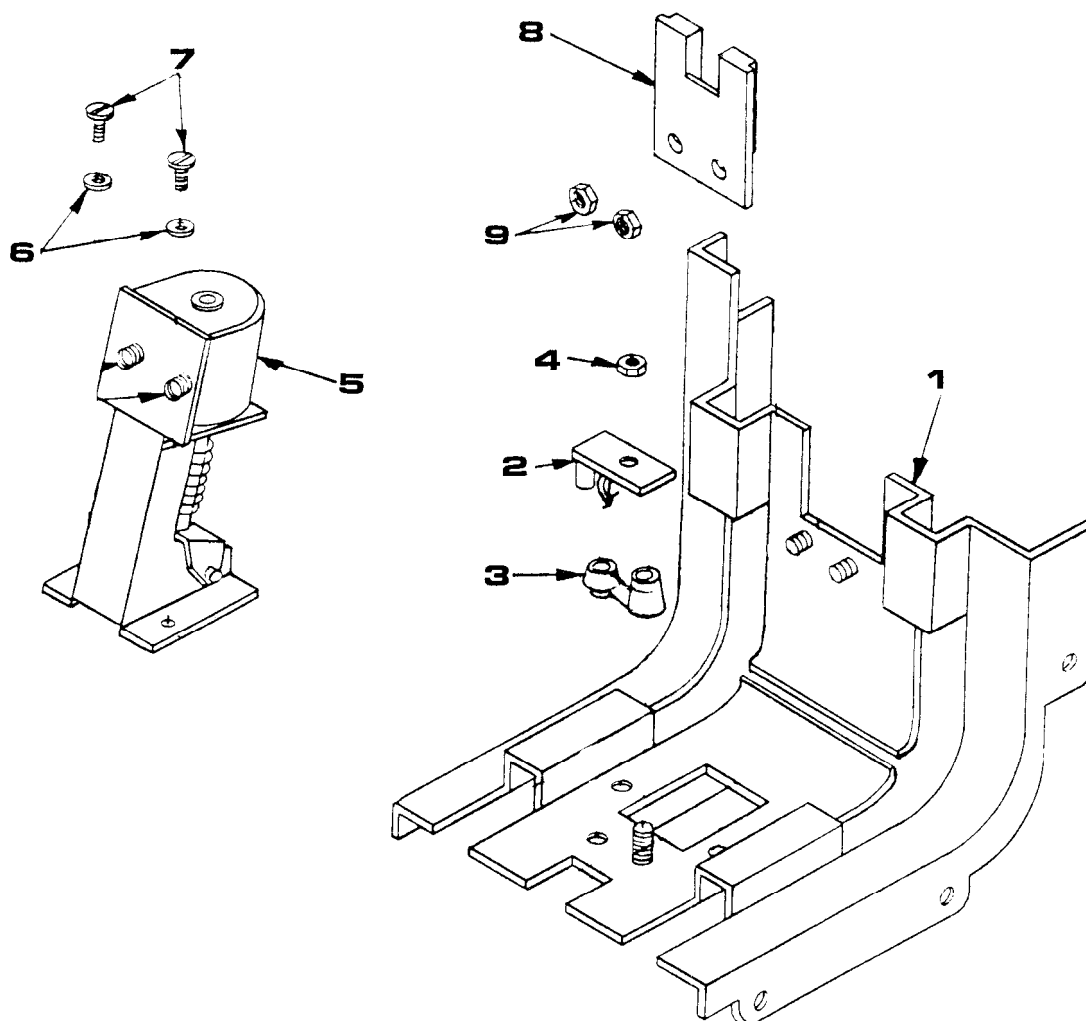
# 2X4143 BOTTOM BILL TRACK

ITEM	PART NUMBER	DESCRIPTION
1	11x1158	Bottom Track
2	2x4149	Bill Present Detector
3	17x874	Emitter-Sensor PCB Mount
4	32x22	#4-40 Hex Nut
5	2x4187	Mag Head Pressure Roller
6	31x59	Flat Washer
7	30x95	#4-40 Screw
8	17x851	Filler, Tine Cutout
9	32x12	#2-56 Hex Nut

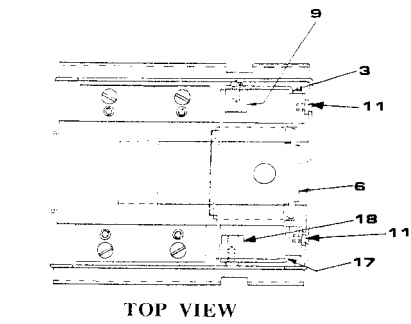
TOP VIEW

# 48X268-1001 MBA BILL STACKER

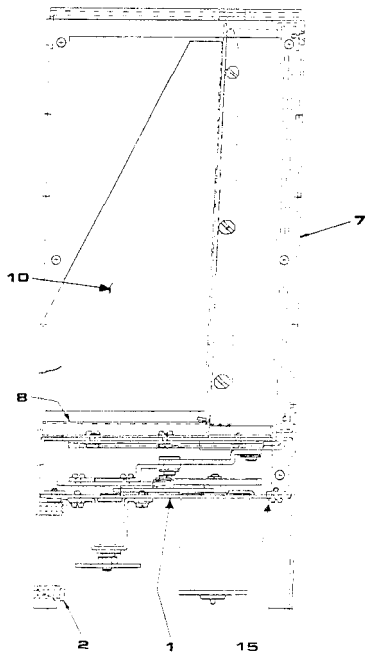
RIGHT SIDE VIEW

HINGE POSITION (RIGHTHAND FRONT)

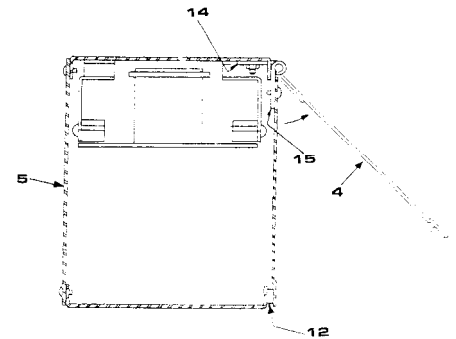
HINGE POSITION (RIGHTHAND REAR)

ITEM	PART NUMBER	DESCRIPTION	ITEM	PART NUMBER	DESCRIPTION
1	2x3986-2	Drive Plate Assy	10	17x821	Foam Spacer
2	2x4026	Stacker PC Bd Assy	11	17x871	Spacer, Note Guide
3	11x1260-1	Chute, Left-Hand	12	29x91	Magnetic Strip
4	11x1232	Door	13	29x92-1	Hinge, LH Female
5	11x1238	Side Plate	14	29x92-2	Hinge, LH Male
6	11x1259	Note Punch Weldment	15	29x92-3	Hinge, RH Female
7	11x1234	Stacker Weldment	16	29x92-4	Hinge, RH Male
8	12x468	Bill Spacer	17	11x1260-2	Chute, Right-Hand
9	17x828-1	Spacer, Left-Hand	18	17x828-2	Spacer, Right-Hand

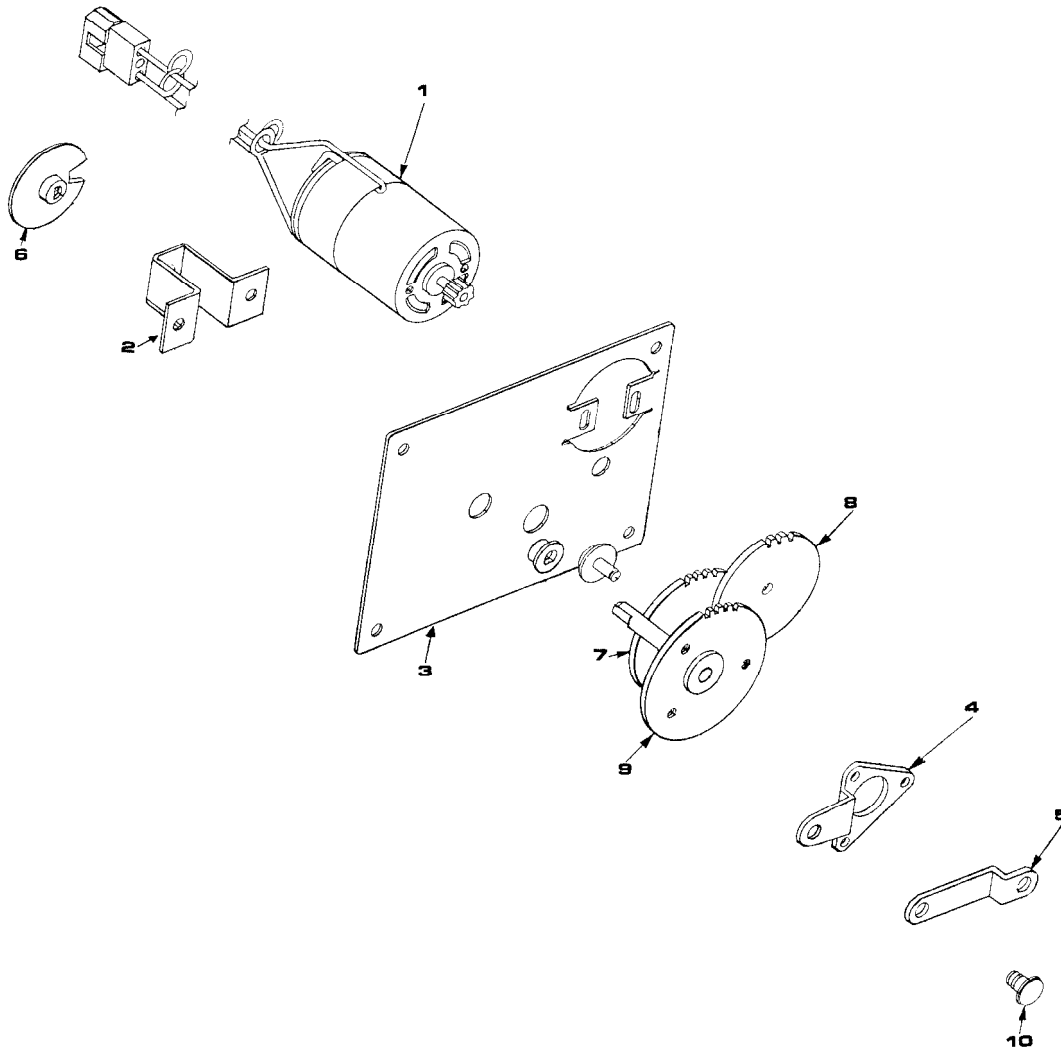
# 2X3986-2 DRIVE PLATE

ITEM	PART NUMBER	DESCRIPTION
1	2X3988	Motor w/Plug Assembly
2	2x4181	Bearing Bracket Assembly
3	2x4182	Drive Train Plate Assembly
4	12x466	Crank
5	12x474	Punch Link
6	17x815	Disc, Optical Interrupt
7	18x19	Combination Gear
8	18x39	Combination Gear
9	18x40	Crank Gear Assembly
10	20x349	Crank Link Pin

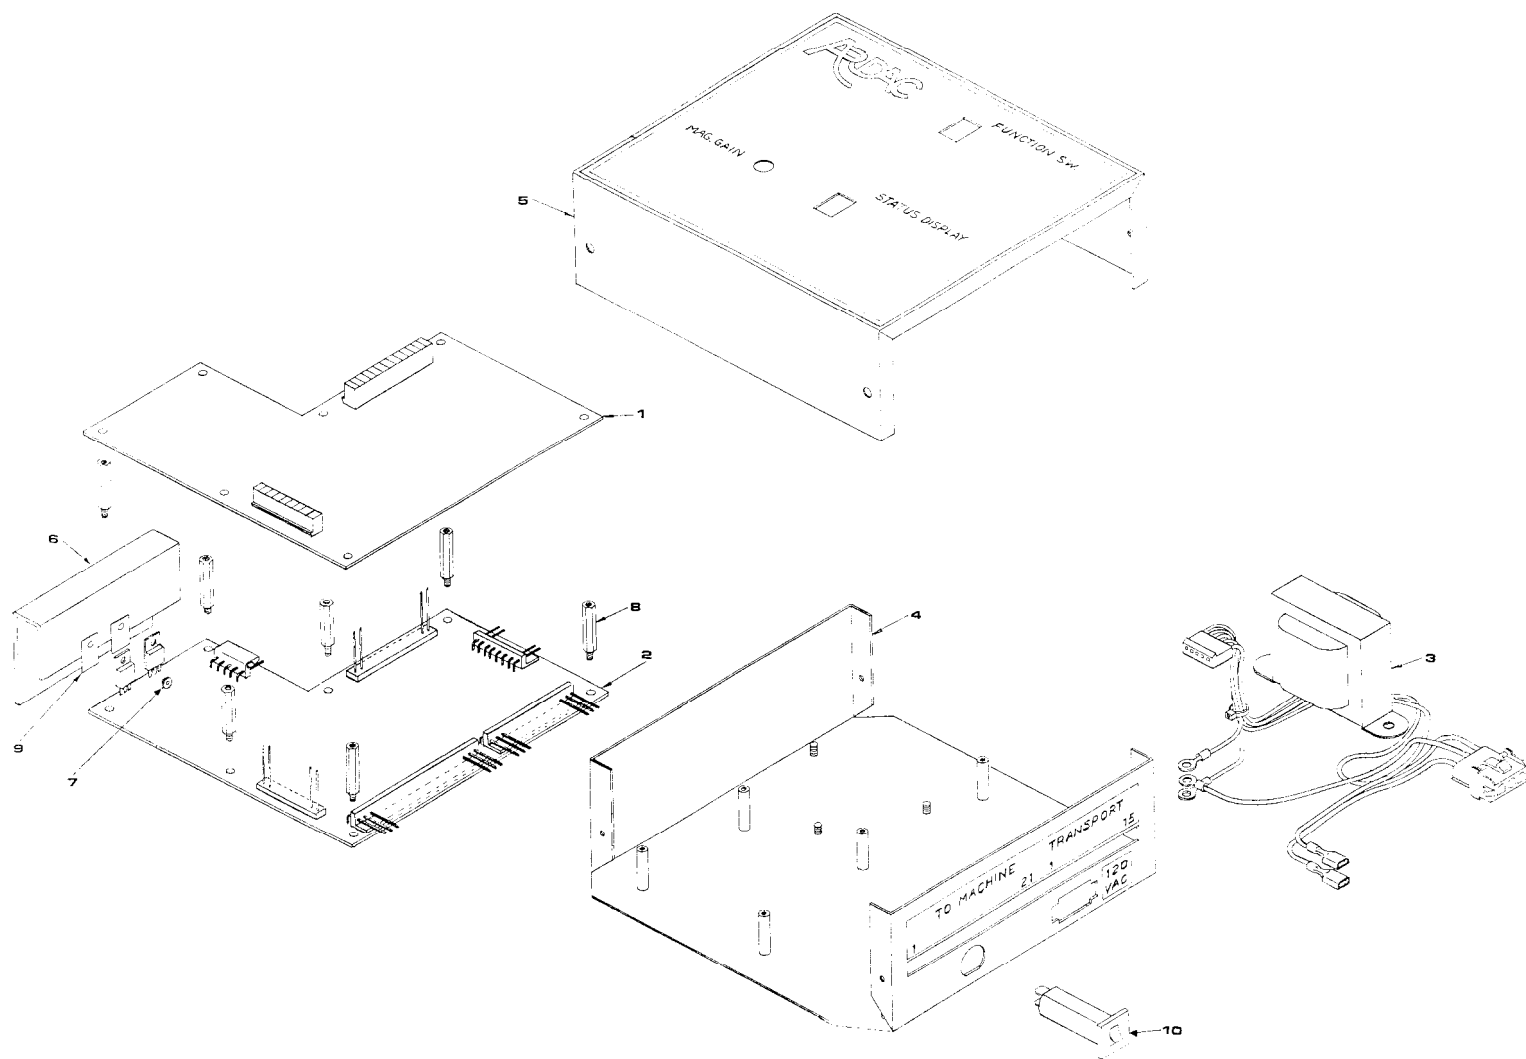
# 1X223-0005 MBA CONTROL BOX

ITEM	PART NUMBER	DESCRIPTION
1	2x3884	Micro PC Board Assembly
2	2x4138 2x3885 2x4031	I.O. & Power PC Bd. (Univ.) I.O. & Power PC Bd. (DC) I.O. & Power PC Bd. (AC)
3	2x4234	Transformer Assembly
4	11x1202	Enclosure, Power Supply
5	9x821	Control Box Cover w/Silk Screen
6	11x1204	Heat Sink Bracket
7	17x258	Insulator Washer
8	21x43	Spacer
9	37x16	Insulator TO-220
10	65x290	Circuit Breaker
