Electronic Servicing

Capacitor roundup issue

AGC basics

Selecting replacement capacitors

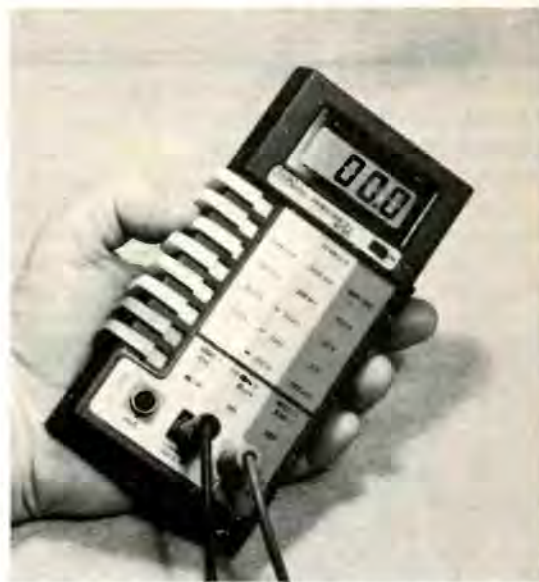
Figure 1 Data Precision model 936 has all customary 3½-digit DMM features in addition to beep tones indicating the start of continuity and continuous sounds for overvoltages.

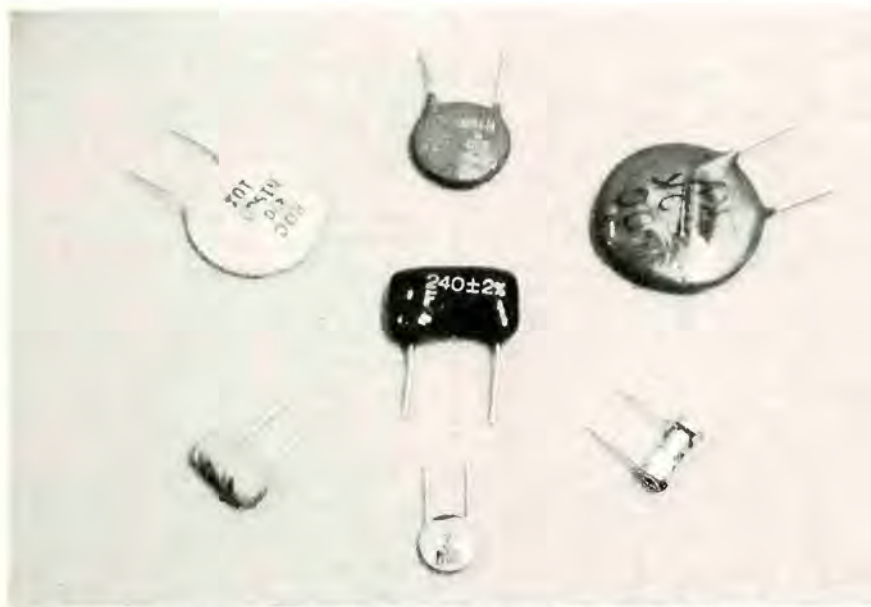
Six types of ceramic capacitors are grouped around a dipped-mica. Mica capacitors continue to be specified where stability and dependability are factors. Ceramic capacitors offer many different specifications.

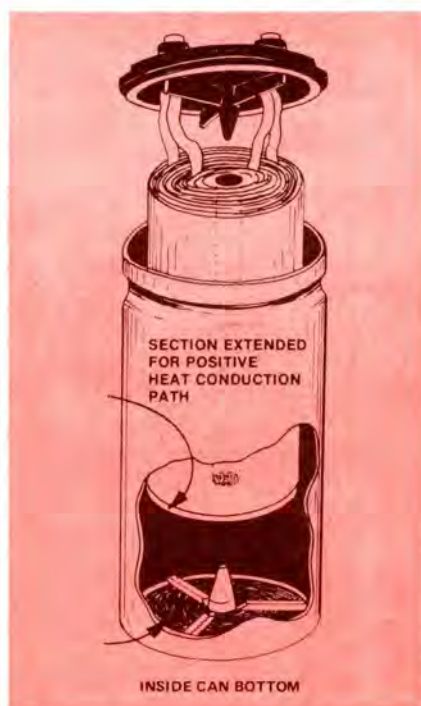
Some computer-grade electrolytic capacitors have this internal construction. *Courtesy of Sangamo.*

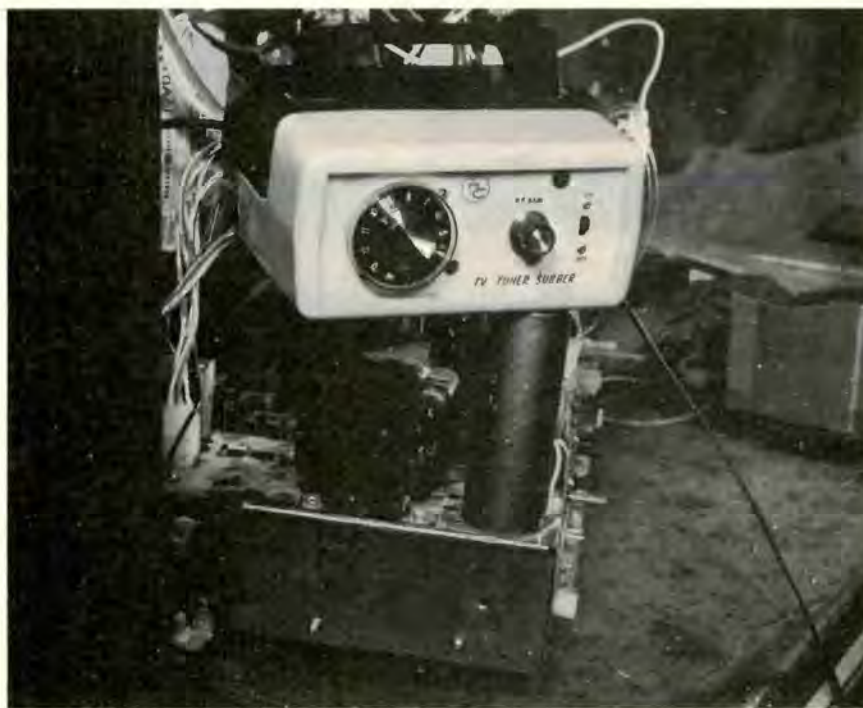
Figure 2 Some tuner defects give symptoms of AGC failures. If connecting a tuner-substitute to replace the TV tuner temporarily provides good reception, then the TV tuner is defective or some voltage at the tuner is incorrect.

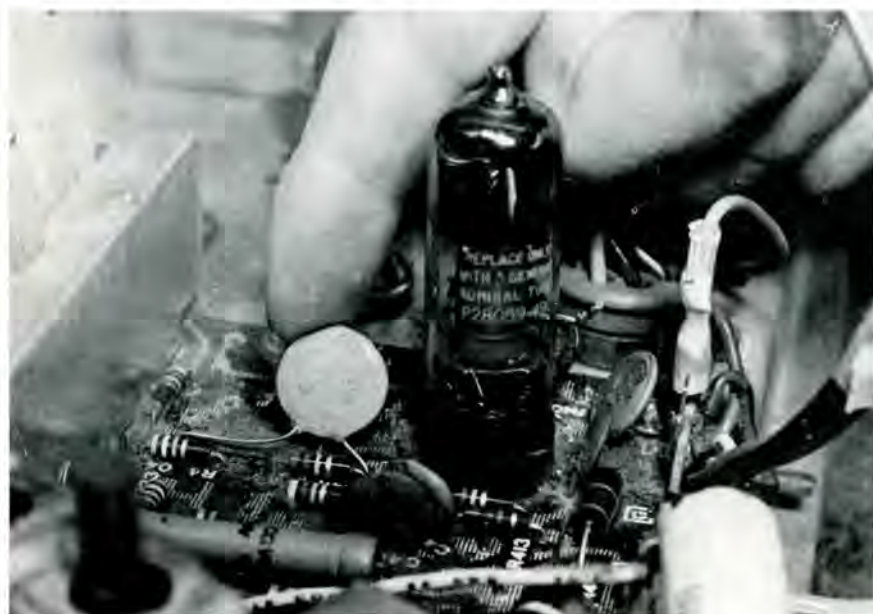
Figure 5 Failure of all AGC action and a dark overloaded picture resulted from a leaky C416 ceramic capacitor in an Admiral G13 chassis. C416 couples horizontal pulses to the AGC-keyer plate.

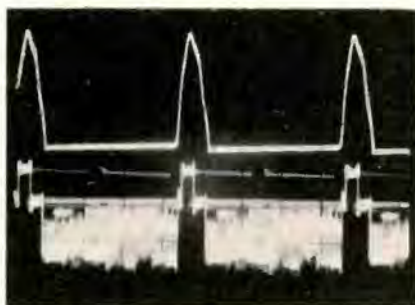
Figure 2 The top waveform shows typical positive-going horizontal-sweep pulses at the AGC-keyer plate. Positive-going video is applied to the grid (bottom dual-trace waveform), where it makes possible plate-cathode rectification which generates a negative voltage.

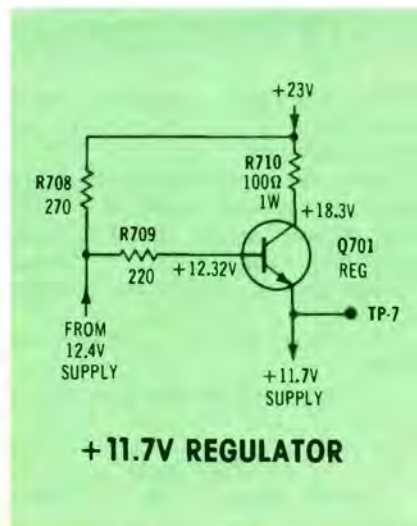
Figure 6 The +11.7V supply for luminance and chrominance circuits comes from this dcV regulator, but it is controlled by the voltage of the +12.4V supply.
