October, 1974
75 cents

Electronic Servicing

SERVICING SCR SWEEP

Rare cases of SCR-sweep defects

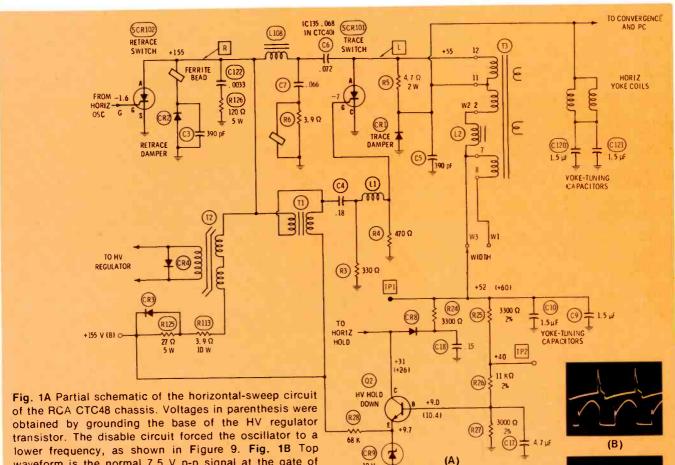
Arrows point to some of the components and test points of the RCA CTC58 chassis. The CTC48 is nearly the same, and other XL-100 chassis are similar

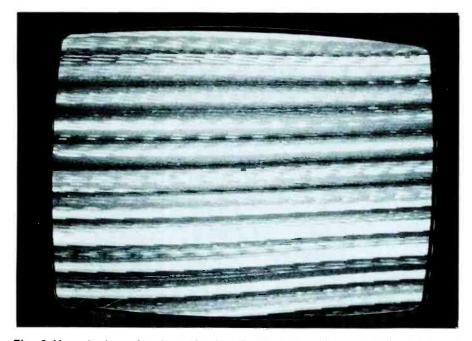
Fig. 9 Many horizontal stripes slanting down to the left resulted from normal action of the disable circuit when the HV regulation was inoperative.

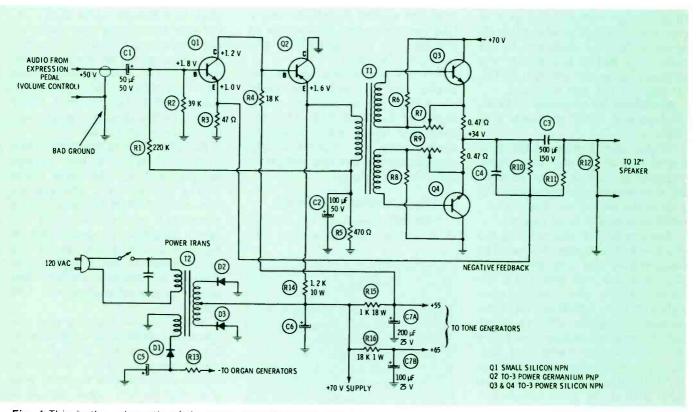
Fig. 1 This is the schematic of the organ amplifier that gave our technician so much trouble. See if you find the defect before he does.

Perhaps C2 was leaking. That would reduce the emitter voltage the same as too much collector/ emitter current. However, C2 was okay. When Q2 was removed and the power applied, the emitter voltage shot up high and R5 started to overheat. This proved excessive transistor current was responsible for the low voltage.

The next wrong voltage was the forward bias of Q2, which measured -.4 volt from the emitter. That's too high for a germanium (-.2 to -.25 volt would be more reasonable). The base was not posi-

tive enough, measured from ground, and that directed suspicion to Q1, because the collector was directly connected to the base of Q2.

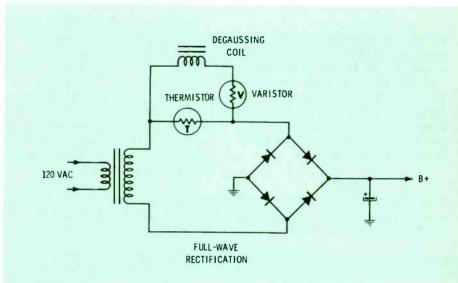
Fig. 1 A typical older degaussing circuit. At turn-on the thermistor is about 120 ohms, so most of the capacitor-charging current flows through the degaussing coil and the varistor. Voltage drop across the thermistor causes it to heat and reduce resistance. This reduces the current through the degaussing coil, and the varistor (because it has less voltage across it) increases resistance to further reduce the current. At maximum temperature, the thermistor has only 2 or 3 ohms resistance, and because of varistor and thermistor actions the current through the degaussing coil is nearly zero. Degaussing takes place each time the receiver is turned on from a cold start.

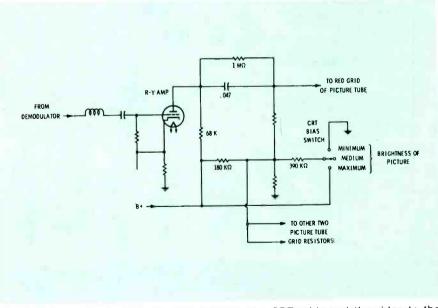
Fig. 5 Older receivers with the color going to the CRT grids and the video to the cathodes can develop dim pictures because of defects in the CRT Bias-Switch circuit. Usually the CRT grids are more positive than the -Y plates, when there is no defect.

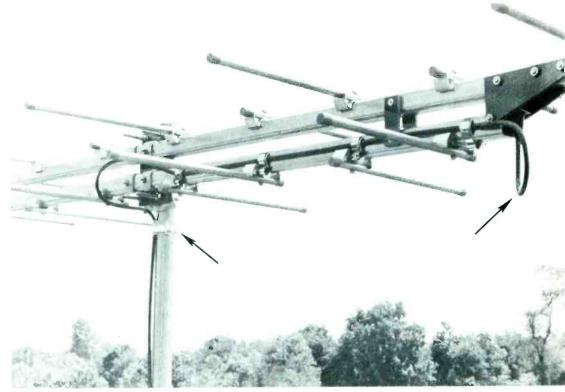
Fig. 1 Add a drip loop at the ends of a horizontal run of cable outdoors (arrow at the right) to prevent moisture from entering. Tape the cable to the mast (arrow at left) and add a strap for strength. Don't crush the cable or make sharp bends.

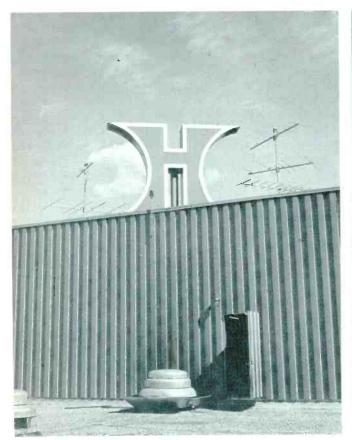
Fig. 4 Large installations often require multiple antennas.

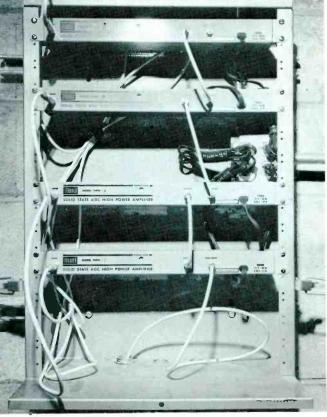
Fig. 5 Mounting in a 19" rack is preferred for single-channel strips and modulators. Notice there are no sharp bends of the cables, and the AC wires have three conductors for safety and UL approval.

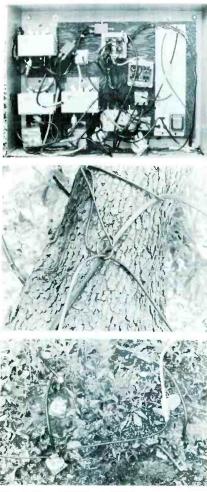
Fig. 7 These pictures show poor workmanship that made necessary replacement of the system after a year because of excessive service.
